DEPARTMENT OF TRANSPORTATION**DIVISION OF ENGINEERING SERVICES**

Office of Structural Materials

Contract #: 04-0120F4Cty: SF/ALA Rte: 80 PM: 13.2/13.9File #: 69.28**WELDING INSPECTION REPORT****Resident Engineer:**Pursell, Gary**Address:** 333 Burma Road**City:** Oakland, CA 94607**Report No:** WIR-016274**Date Inspected:** 05-Aug-2010**Project Name:** SAS Superstructure**OSM Arrival Time:** 1900**Prime Contractor:** American Bridge/Fluor Enterprises, a JV**OSM Departure Time:** 700**Contractor:** Zhenhua Port Machinery Company, Ltd (ZPMC), Changxing Island **Location:** Shanghai, China**CWI Name:** See Below**CWI Present:** Yes No**Inspected CWI report:** Yes No N/A**Rod Oven in Use:** Yes No N/A**Electrode to specification:** Yes No N/A**Weld Procedures Followed:** Yes No N/A**Qualified Welders:** Yes No N/A**Verified Joint Fit-up:** Yes No N/A**Approved Drawings:** Yes No N/A**Approved WPS:** Yes No N/A**Delayed / Cancelled:** Yes No N/A**Bridge No:** 34-0006**Component:** OBG**Summary of Items Observed:**

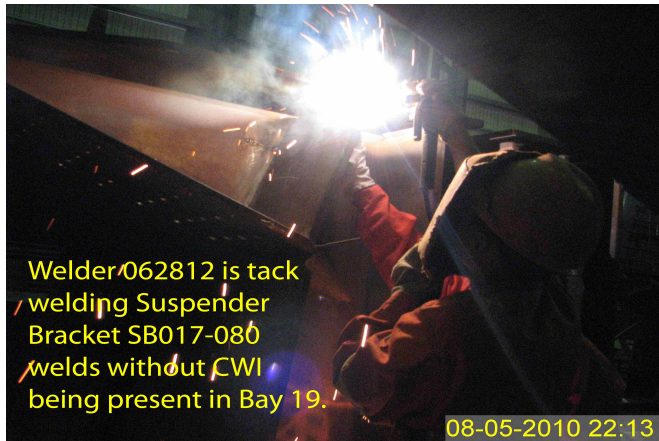
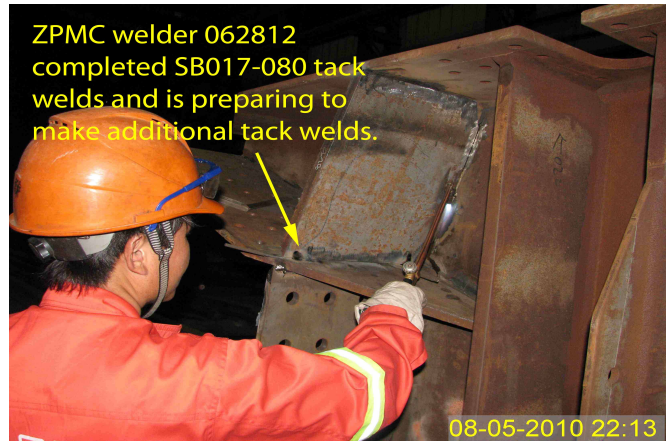
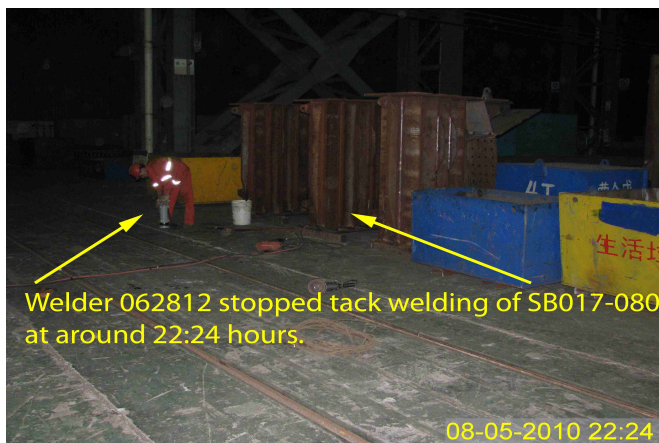
This QA Inspector observed ZPMC welder Mr. Wang Qixiang, stencil 062812 was using shielded metal arc welding process to make Suspender Bracket tack welds SB017-080-010, -011, -013, -015, -017 and 018. This QA Inspector observed no Certified Welding Inspector (CWI) or other Quality Control personnel appeared to be in Bay 19. This QA Inspector contacted ZPMC QA representative Mr. Zhang Wei who stated that ZPMC production had informed ZPMC QC that no welding would be performed in Bay 19 and that no QC CWI or other inspection personnel had been assigned to monitor welding in Bay 19. This QA Inspector informed Mr. Zhang Wei that an incident report would issued to document ZPMC performing welding without a CWI being present. See the photographs below for additional information. Items observed on this date do not appear to fully comply with applicable contract documents.
